October 19, 2022

Dear Valued Parafilm Customer,

**Amcor Flexibles North America**  
2200 Badger Avenue Oshkosh, WI 54904  
[www.amcor.com](http://www.amcor.com)

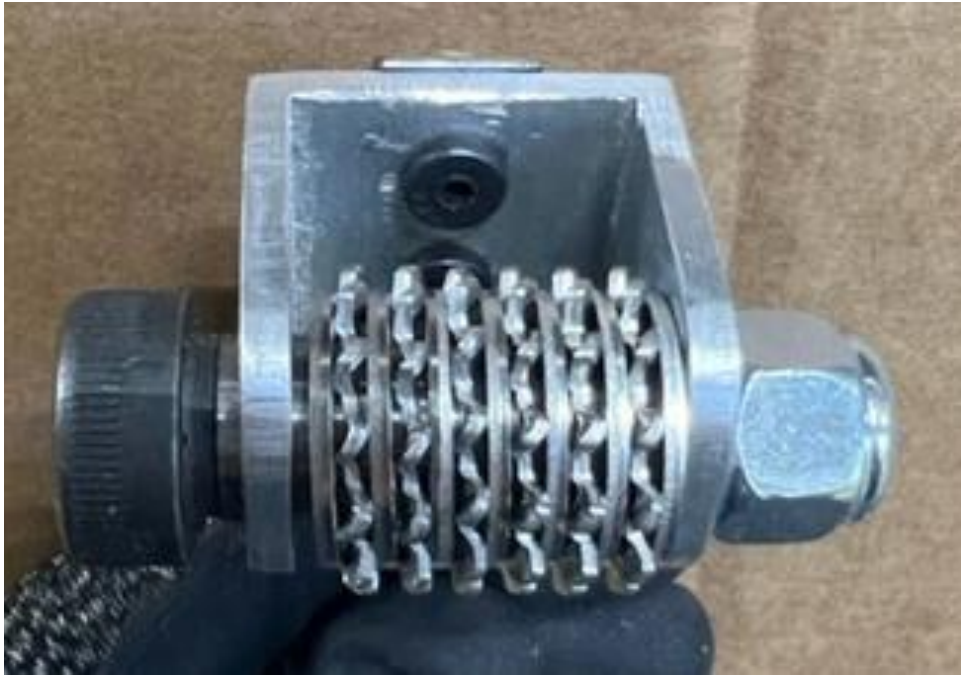
Tail Wipe Mechanism

Recently our Parafilm operation has been upgraded from a manual process to an automated solution. The noticeable change in appearance, largely at the top of each roll, is due to our tail wipe system. As the rolls are taken off the line the unsecured end, or tail, must be secured for it to feed down our packaging line. To secure the tails, the finished rolls are spun against a stationary piece with free spinning indentation wheels while light pressure is applied. While this secures the tails, it also causes a visual marking on the material.

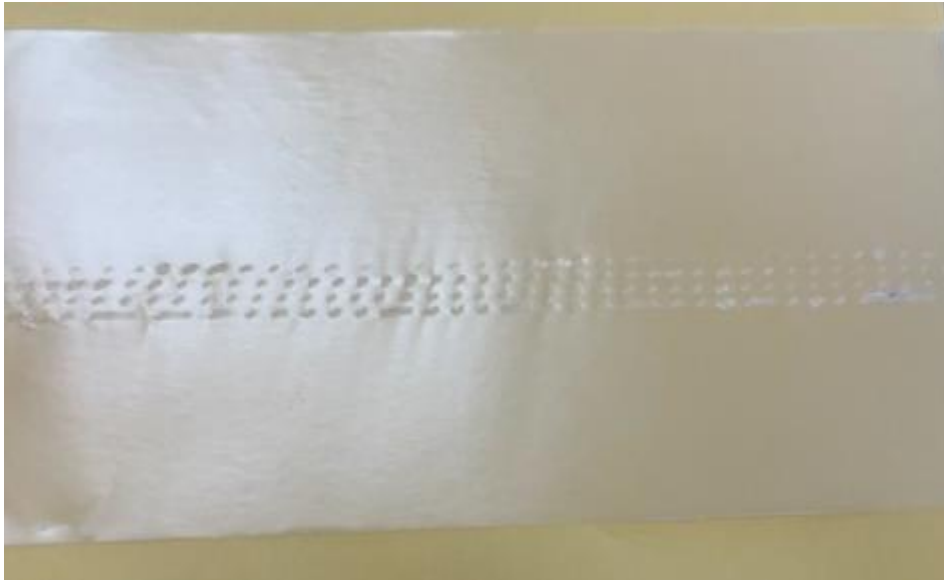
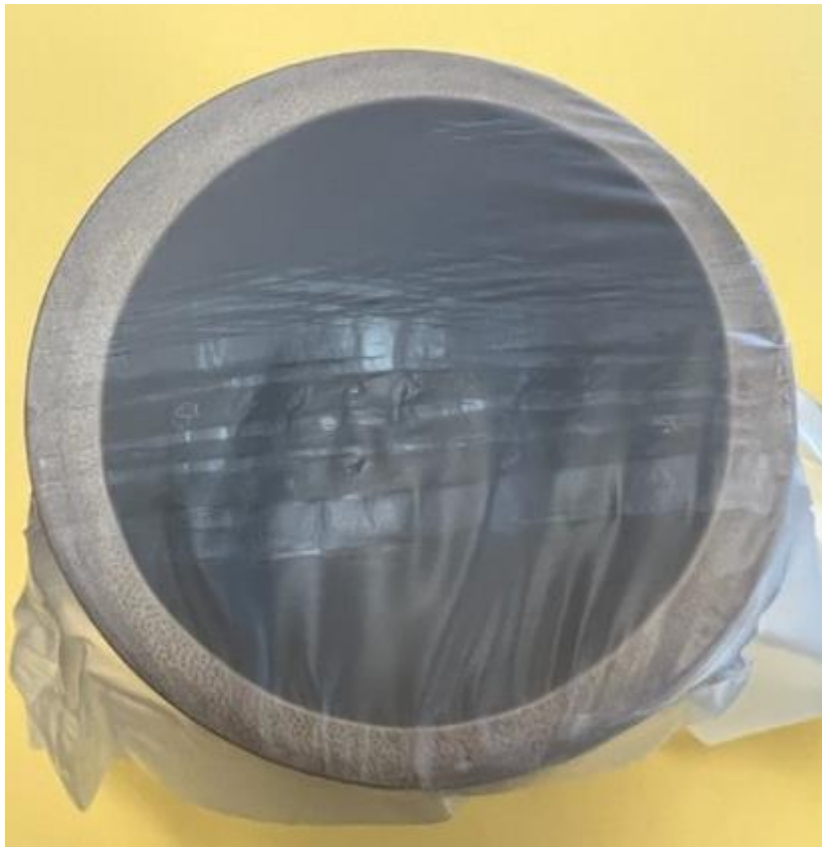
Top of Roll

Past potentially the first wrap, this marking will be purely a visual defect and will not affect the functionality of the film. The pressure applied is not great enough to puncture the Parafilm to the point where functionality is affected past the first wrap.
